HCAT PROGRESS REPORT SEPTEMBER 2002

TEST 1: MLG FATIGUE TEST

TEST 3: PISTON FATIGUE TEST

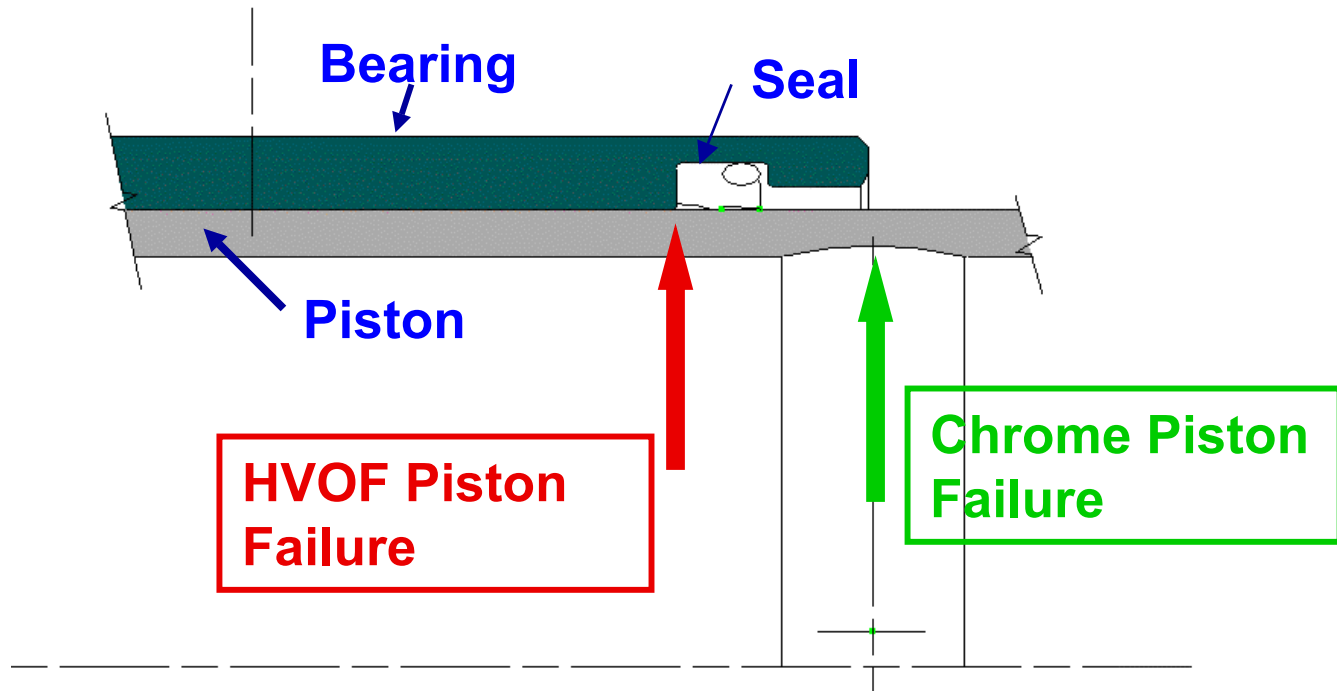
5,000 cycles - some cracking top and bottom

10,000 cycles - significant circumferential cracking

25,300 cycles - failure at the bearing contact point
initiating at bottom

- **HVOF pistons failed at contact point with bearing - Failure originated at OD; Chrome plated pistons failed at notch - Failure originated at ID.**
- **Cracking of coating is circumferential, localized and appears to occur relatively early ~5 K cycles @125ksi**
- **Coating failure is cohesive (substrate still coated).**
- **Coating application and finish - not a factor.**
- **Commercial Landing Gear Stresses are comparable to test - but # of cycles much smaller.**
 - **LG spectrum 125 ksi -- 575 cycles/5 lives (120 one life)**
 - **Test regime 125 ksi -- 5,000 - 7,000 cycles**
- **Test conditions too severe, not representative of LG.**

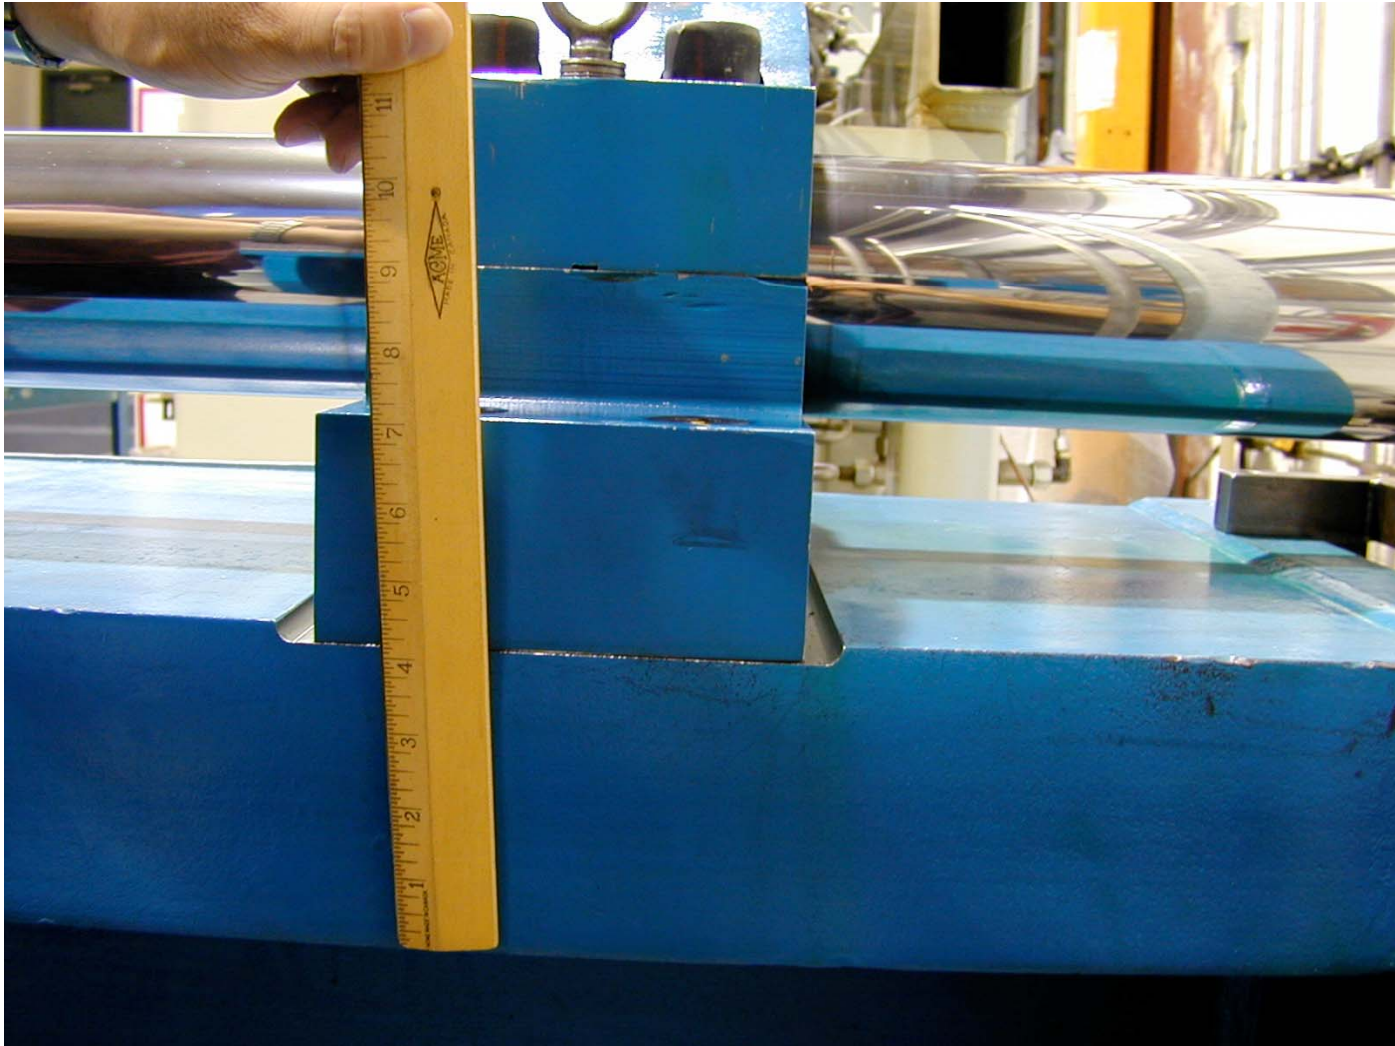
Test conditions too severe, not representative of LG.

Scope of test changed to simulate LG conditions - 10" test

- 10" Rig will be re-designed to represent LG lower bearing**
- Simple spectrum loading will be implemented**
- Representative bearing will be implemented**
